# Corrosive Drywall and other Imported Concerns

## 2013 Annual Georgia Environmental Conference

Presented by: Dr. Jamie Poole, CIH  
Principal, ENVIRON - Tampa

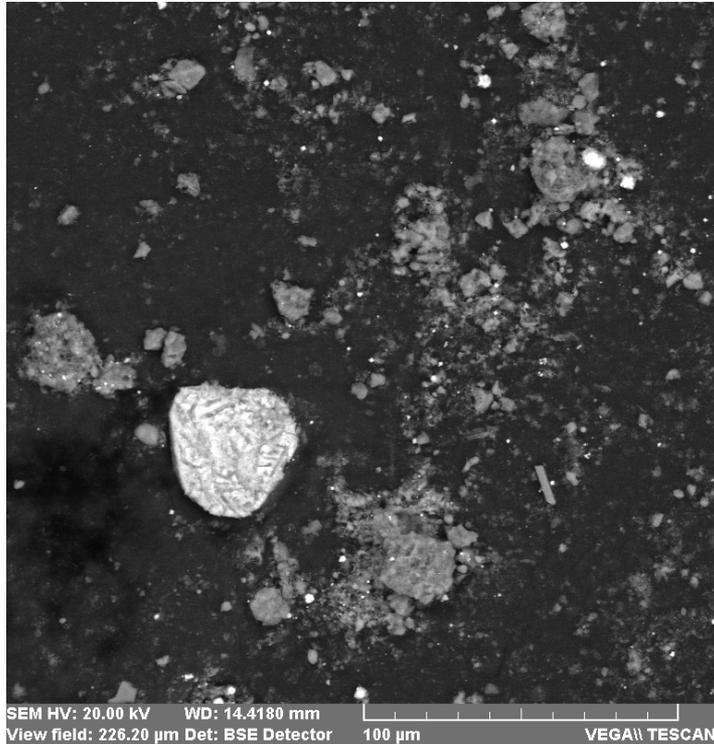
# Elemental Sulfur in Gypsum

Scanning electron microscope image of elemental sulfur particle in gypsum wallboard sample.

- Elemental sulfur is a “sensitive and specific marker of problematic drywall” (EH&E, 2010).
  - Strongly associated with hydrogen sulfide emissions and copper corrosion in chamber experiments.
  - Also associated with hydrogen sulfide levels in indoor air and corrosion of silver and copper coupons as part of the CPSC 51-Home study.
- Present as individual particles in the gypsum matrix.
- Likely originated as sulfur inclusions in mined gypsum.

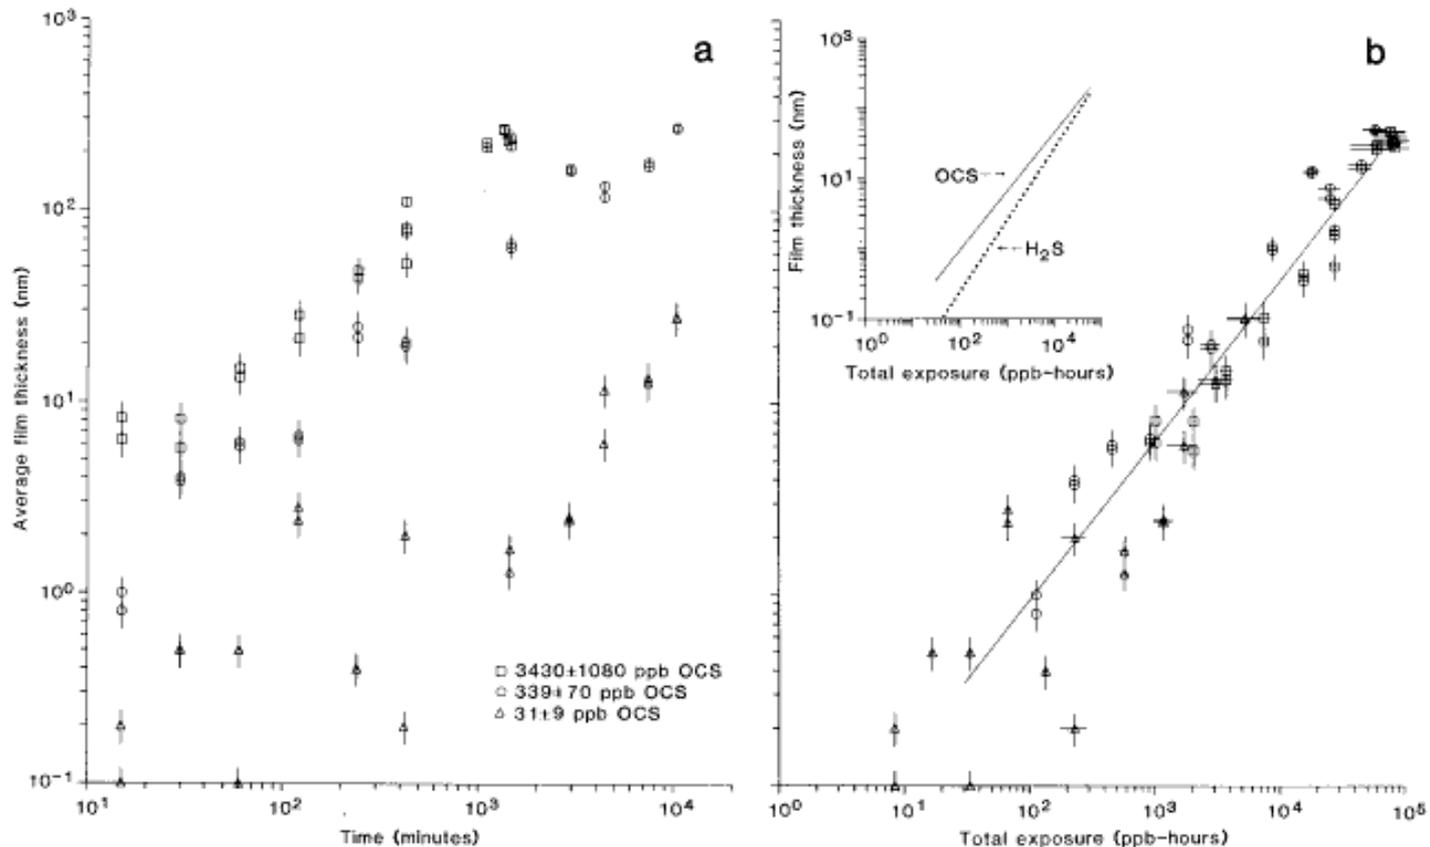
# Rate of Corrosion is Linear with Total Exposure

Fig. 1. (a) Sulfide film thickness as a function of exposure time for different OCS concentrations. All exposures were made within the experimental ranges temperature =  $20^\circ \pm 2^\circ\text{C}$  and relative humidity =  $80 \pm 4$  percent. (b) Sulfide film thickness as a function of total exposure to OCS. The solid line is a least-squares fit to the data points. The inset compares the rate of copper corrosion by OCS to that produced by  $H_2S$  exposure, as determined under the same experimental conditions (9).

- Number of studies have shown that both OCS and H<sub>2</sub>S are corrosive in humid air (e.g. Graedel et al., 1981; Tran et al., 2003).
- **Rate of corrosion is approximately linear with total exposure** (i.e. the product of exposure time and sulfide concentration)(Graedel et al., 1981).
  - Thus, 10 years exposure to 1 ppm produces the same effect as 1 year exposure at 10 ppm.
- Experiments show **corrosion continues even after corrosive wallboard is removed.** (Freeman et al., 2011).

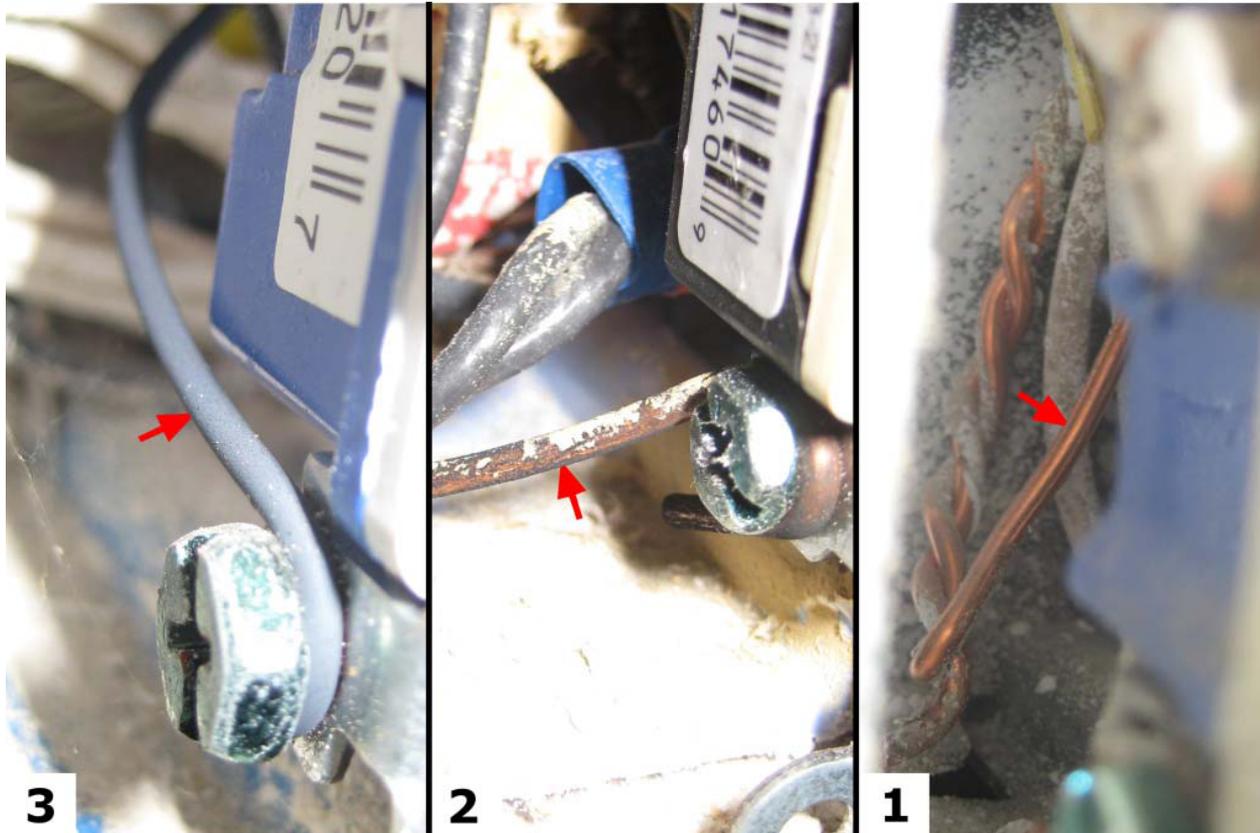
# Visible Corrosion Observed in Most Homes

**Figure 4.1 Example of Visual Corrosion Ratings, Electrical Ground Wire**  
(3—Significant Visible Corrosion, 2—Moderate Visible Corrosion, 1—No Visible Corrosion)

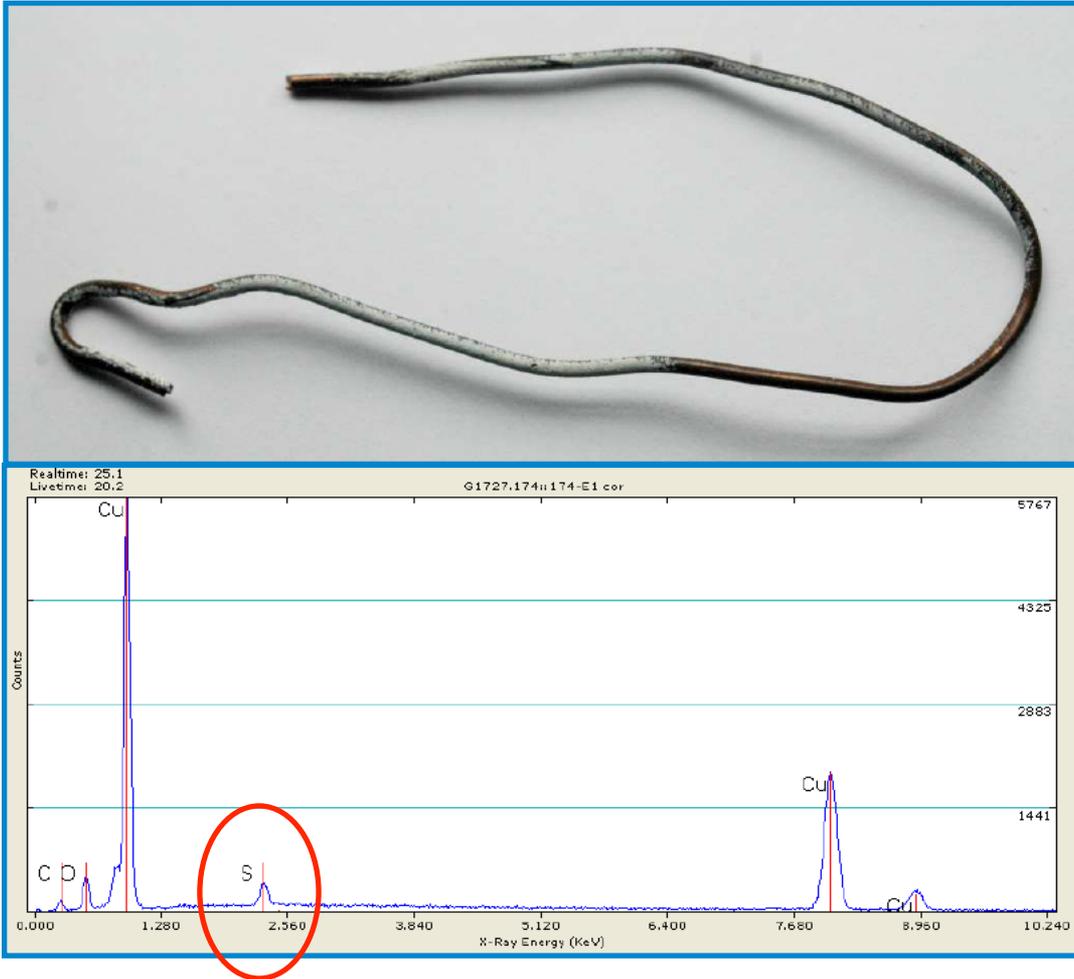
# Sulfur Corrosion Detected on Copper Wire Collected from Residence

“In addition to the paint residue, areas of oxidation and copper oxide/sulfide were present on the surface of this sample. Sulfur was identified as a significant component of some areas of corrosion seen on this sample.”

IMT Gypsum detected at 1.5 to 2.5 ppm
